# Return to Flight Status

# Columbia Investigation

# Columbia Investigation Overview

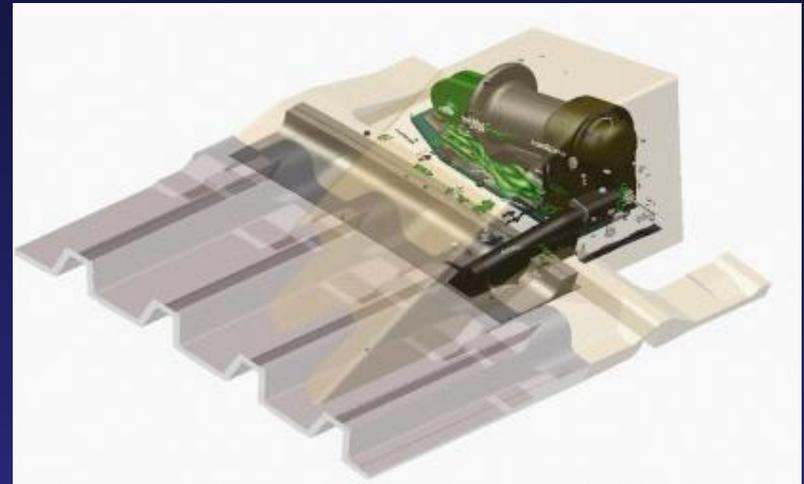
## **Major Findings**

- ***Design verification and process validation did not encompass all material and processing variability or adequately address all failure modes***
- ***Quality Control verification of the manual spray application process did not preclude process variations affecting the part integrity***
- ***Available acceptance testing / inspection techniques were not capable of rejecting ramps with adverse “as-built” features which could threaten the TPS integrity***

***Shuttle, and therefore External Tank, must consider debris as a critical environment***

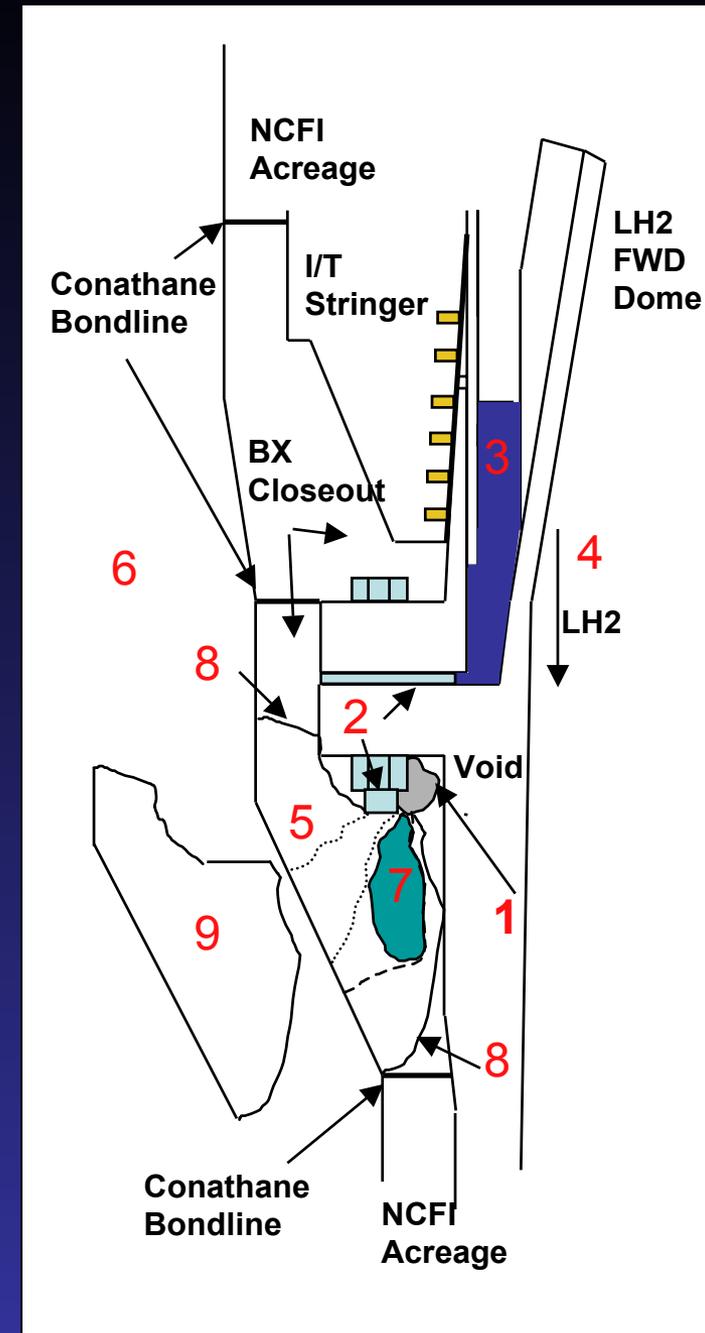
1. LN2 begins to form in voids as LH2 level approaches flange
2. Flange temps rapidly fall to form SN2 in leak paths blocking flow
3. LN2 and SN2 begins to accumulate in Y joint during hold
4. During ascent LH2 level drops, flange temps begin to rise
5. LN2 begins to gasify causing foam to crack
6. Ascent heating weakens outer layer of foam
7. LN2 enters crack and begins rapid gasification
8. Crack rapidly propagates to substrate, conathane, flange
9. Divot produced due to weak outer layer and LN2/GN2

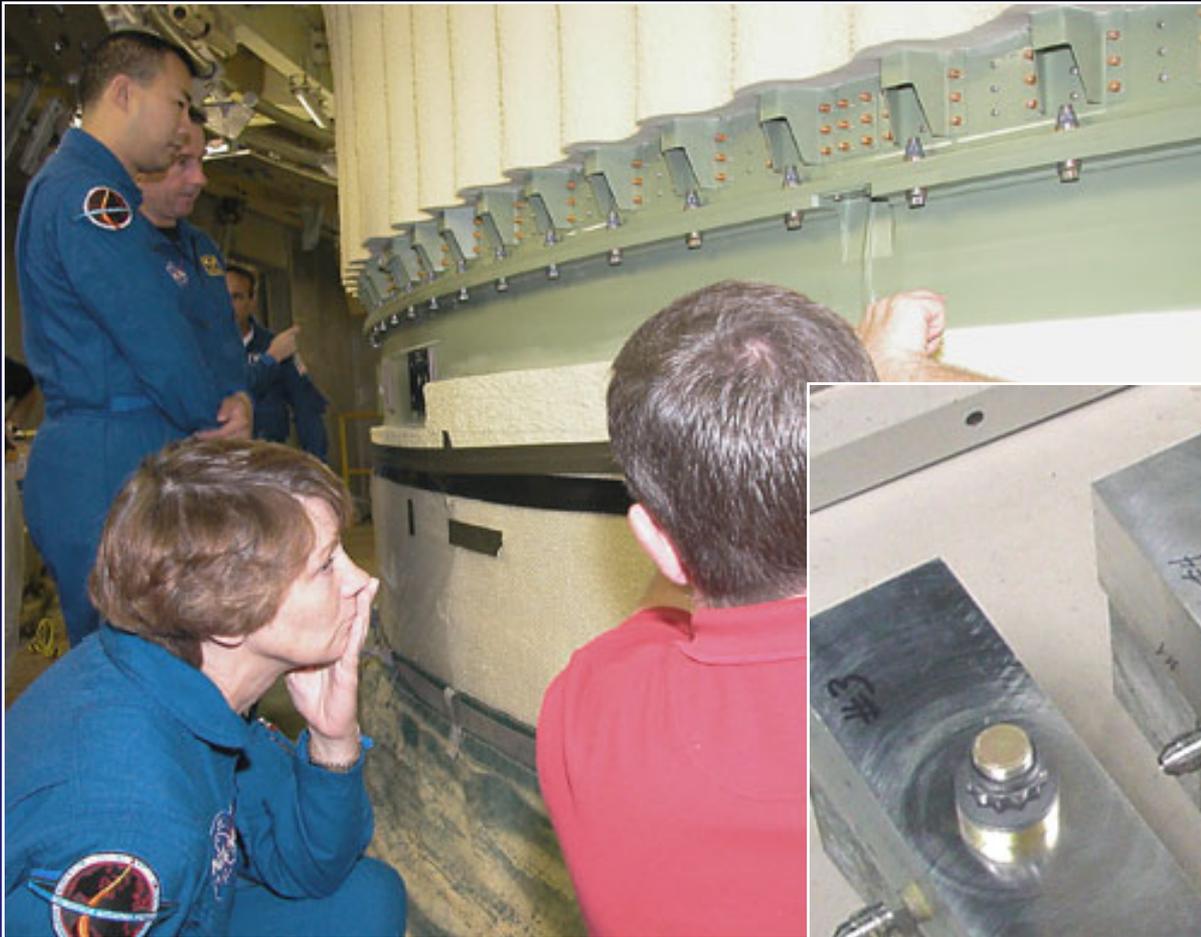
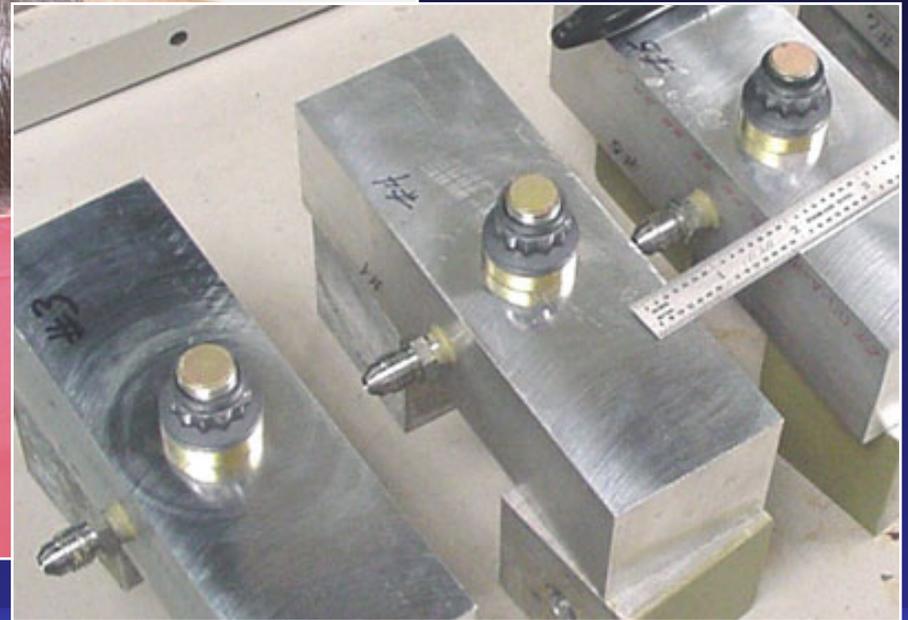
Reversed Bolts

***We are addressing contributors to foam loss on the flange  
(voids and leak path)***

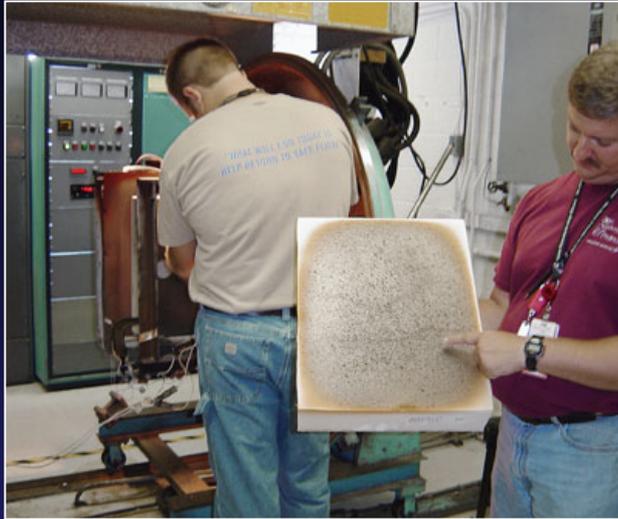
Thermal Vac Test

***Our understanding of the divoting foam loss mechanism has increased dramatically and we continue to aggressively test***

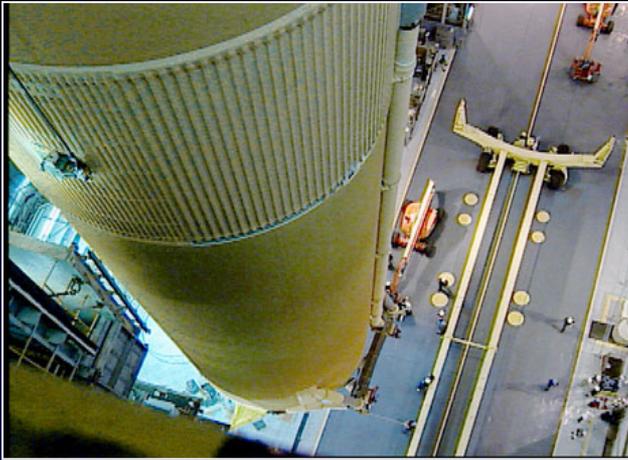
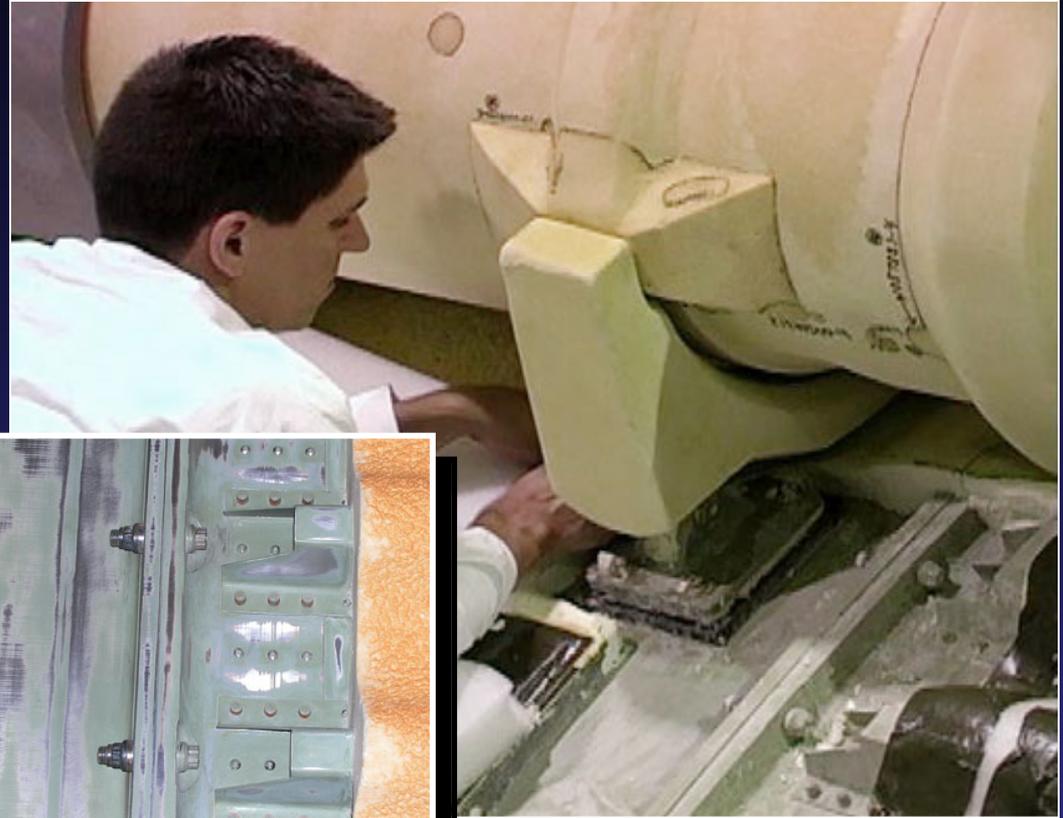
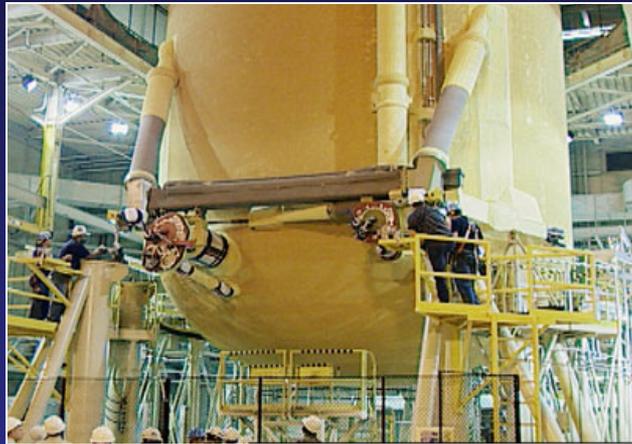
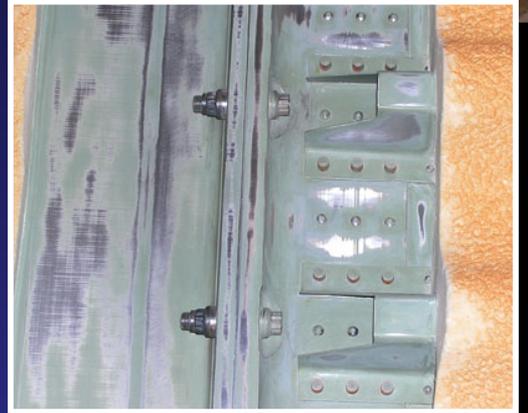
Flange Runs Beneath Feedline

ET Vertical in Cell A

***The manufacturing flow for retrofit External Tanks is radically different than for in-line production, but we are ready to proceed***

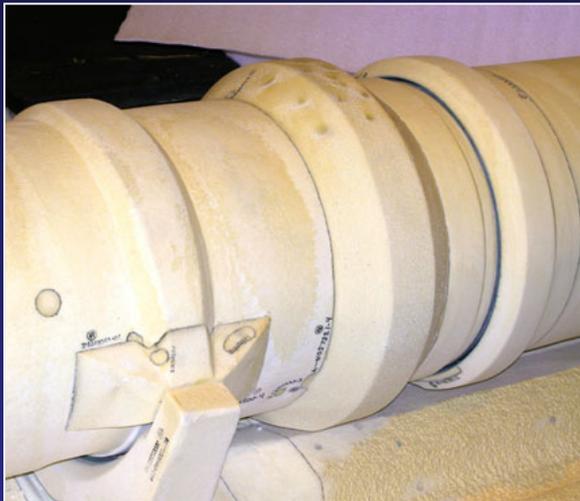
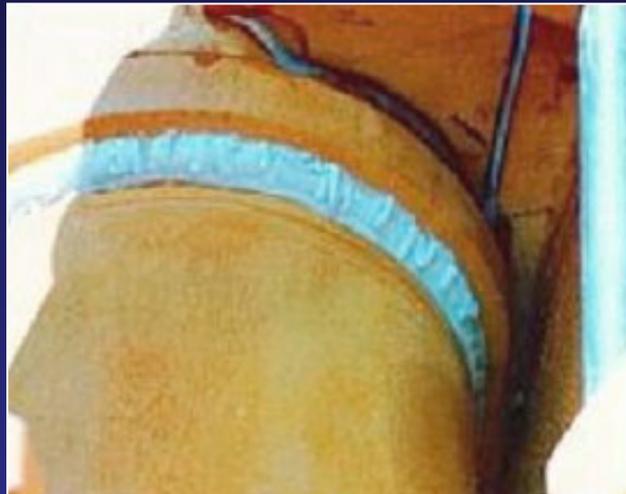
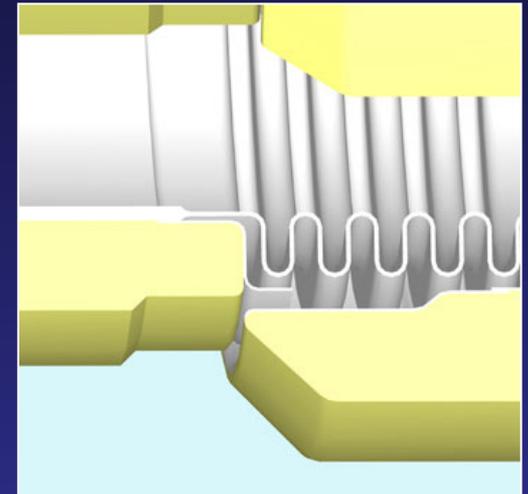
***An additional debris source was identified for elimination***

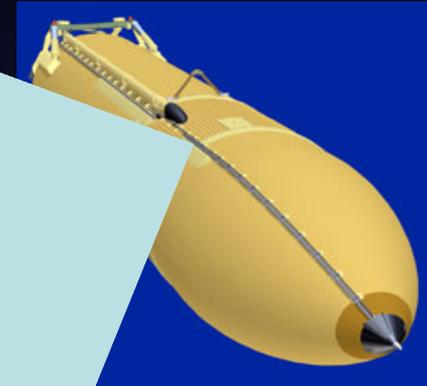
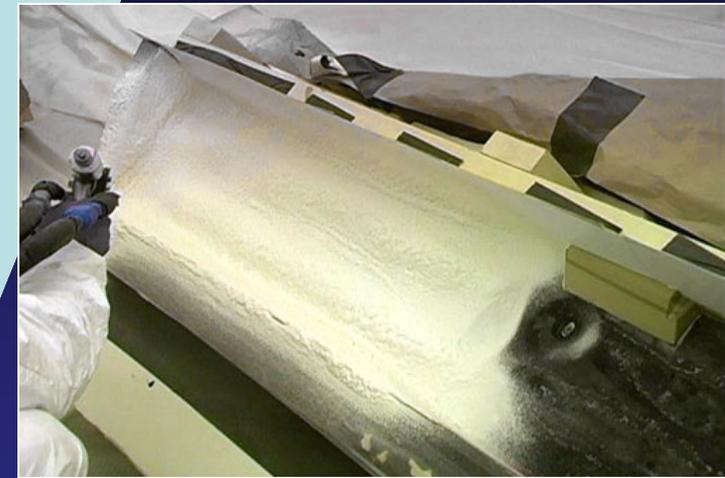
PAL Ramp Spray

Ten Foot Section of Removed PAL Ramp  
with Critical Area Shown in Red Box

***We have removed the PAL ramp over the flange and  
are refining the process to replace it***
